Debris/Ice/TPS Assessment And Photographic Analysis For Shuttle Mission STS-35

Gregory N. Katnik
NASA/Kennedy Space Center

DEBRIS/ICE/TPS ASSESSMENT
AND
PHOTOGRAPHIC ANALYSIS
OF
SHUTTLE MISSION STS-35

December 2, 1990

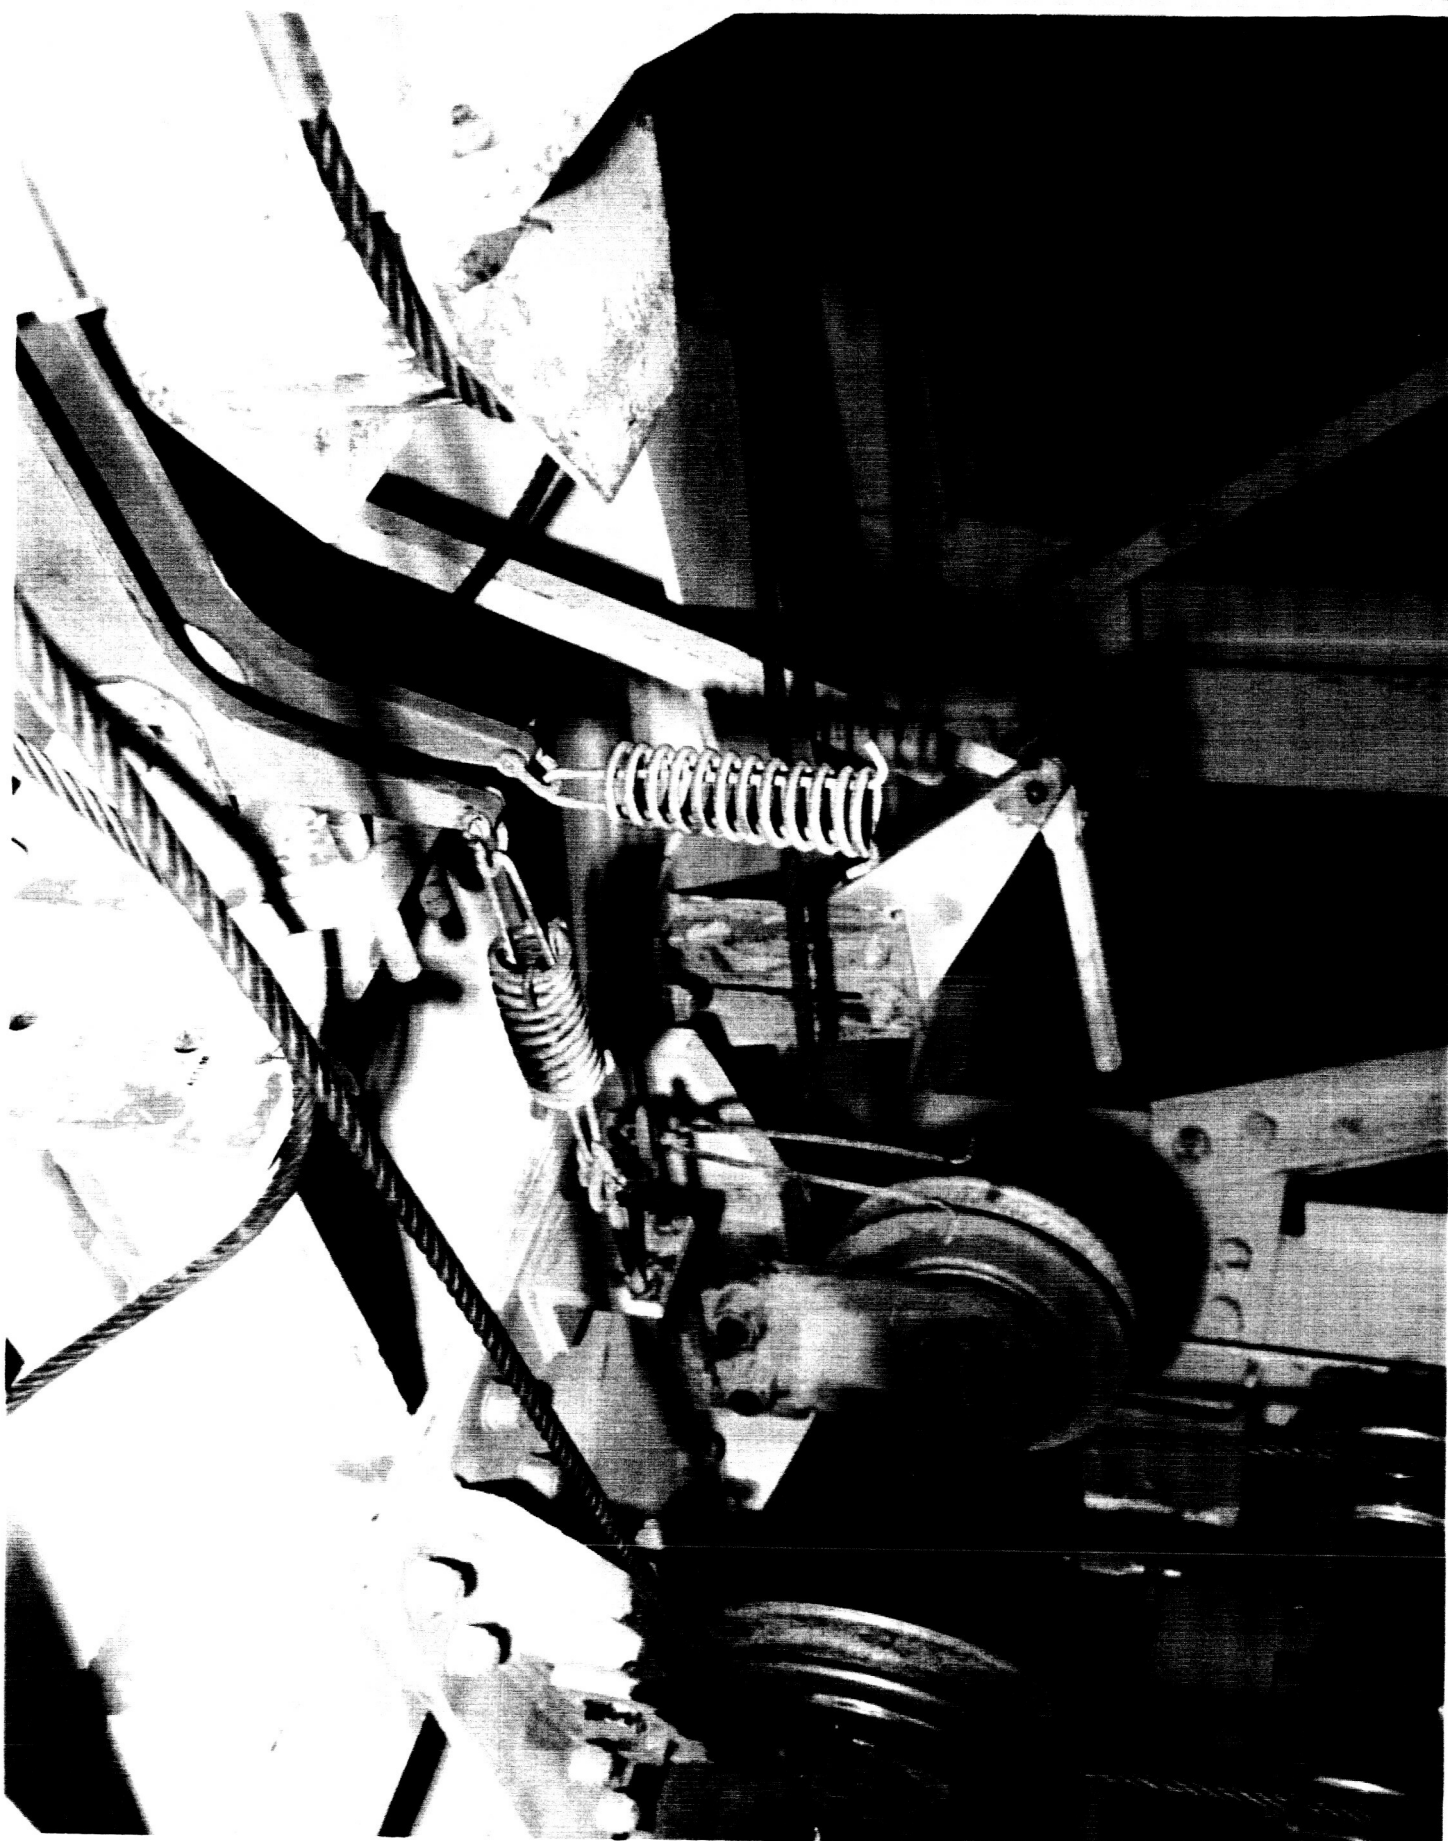
Although the GH2 vent arm retracted normally and latched on the eighth tooth, one of the two ratchet bar spring retention devices failed. The spring broke loose but remained attached to the bar.

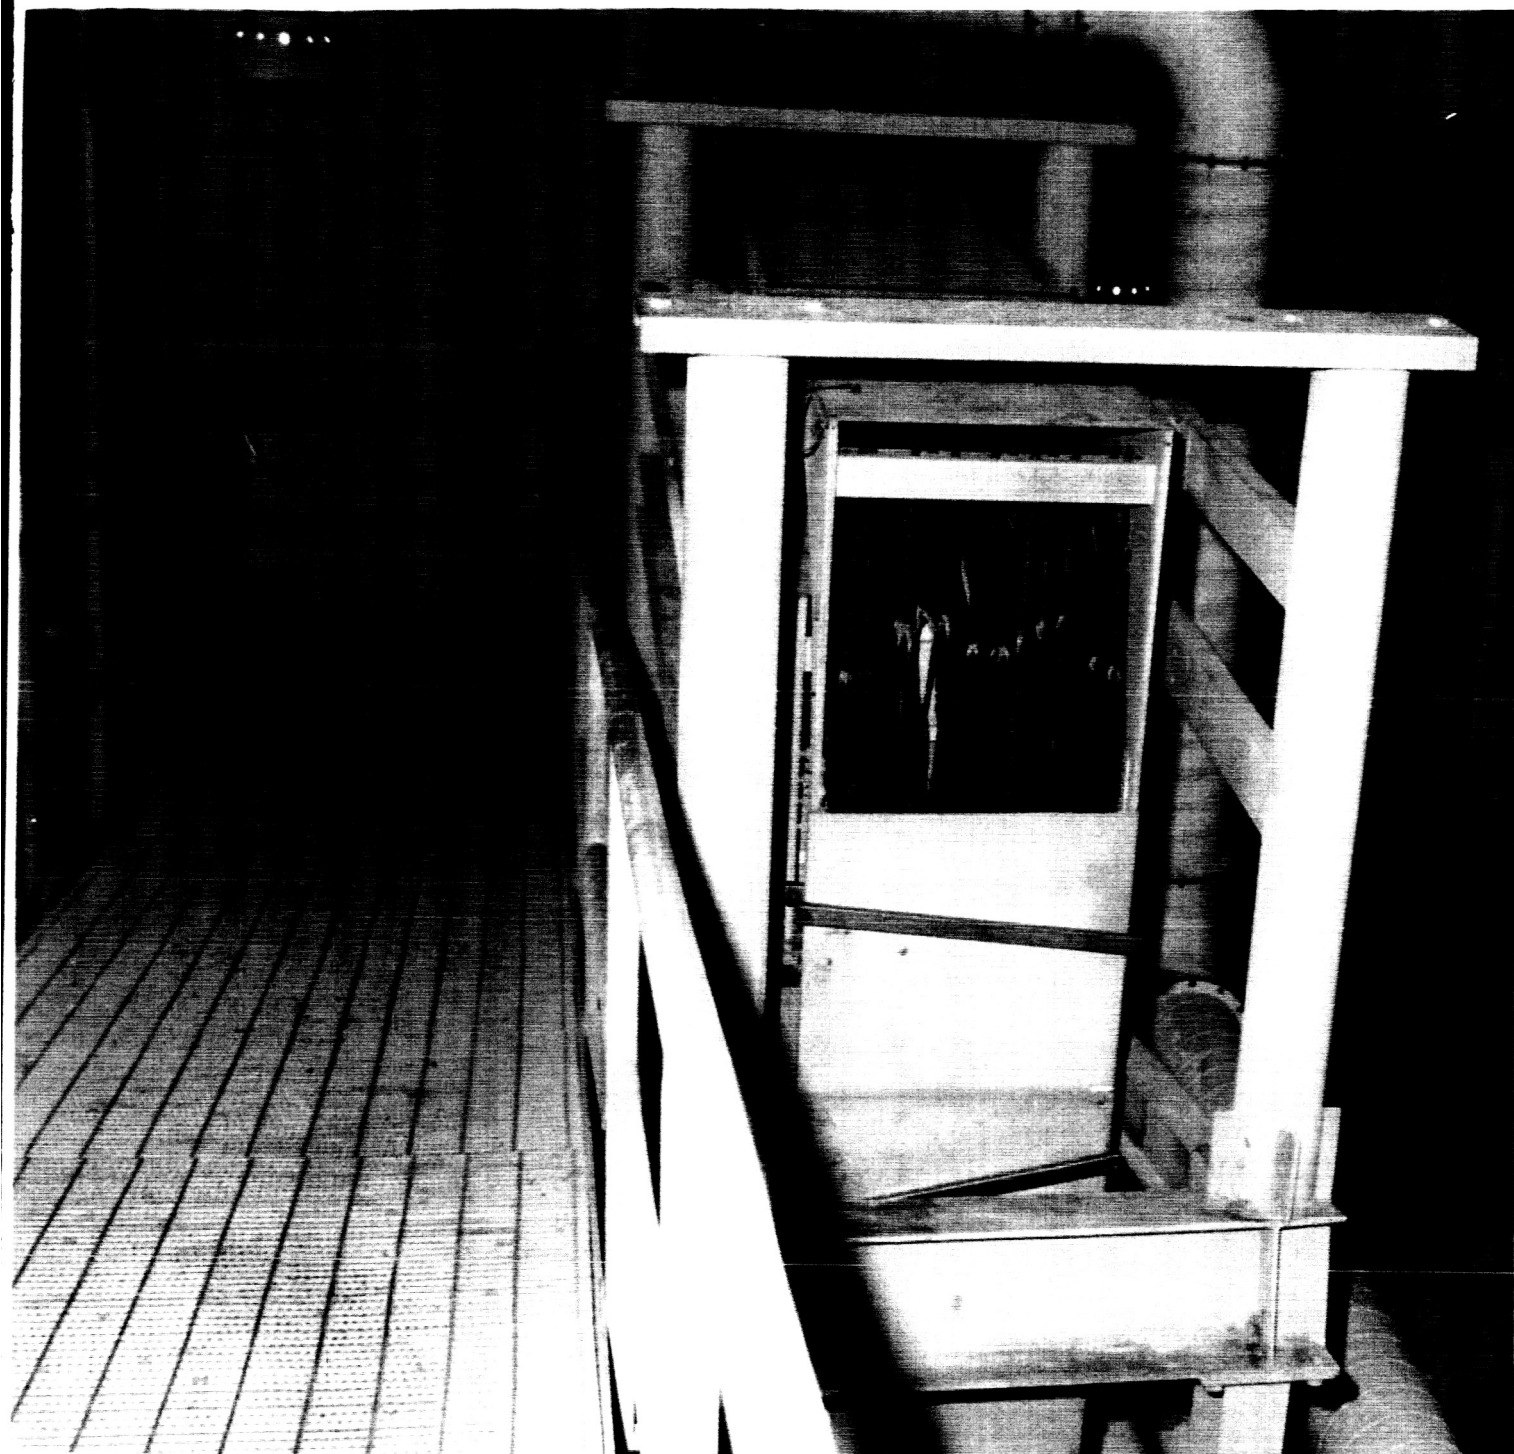
Two cable tray covers were missing from the FSS 215/RSS 207 foot levels after launch. Several large covers were loose on the RSS 135 foot level.

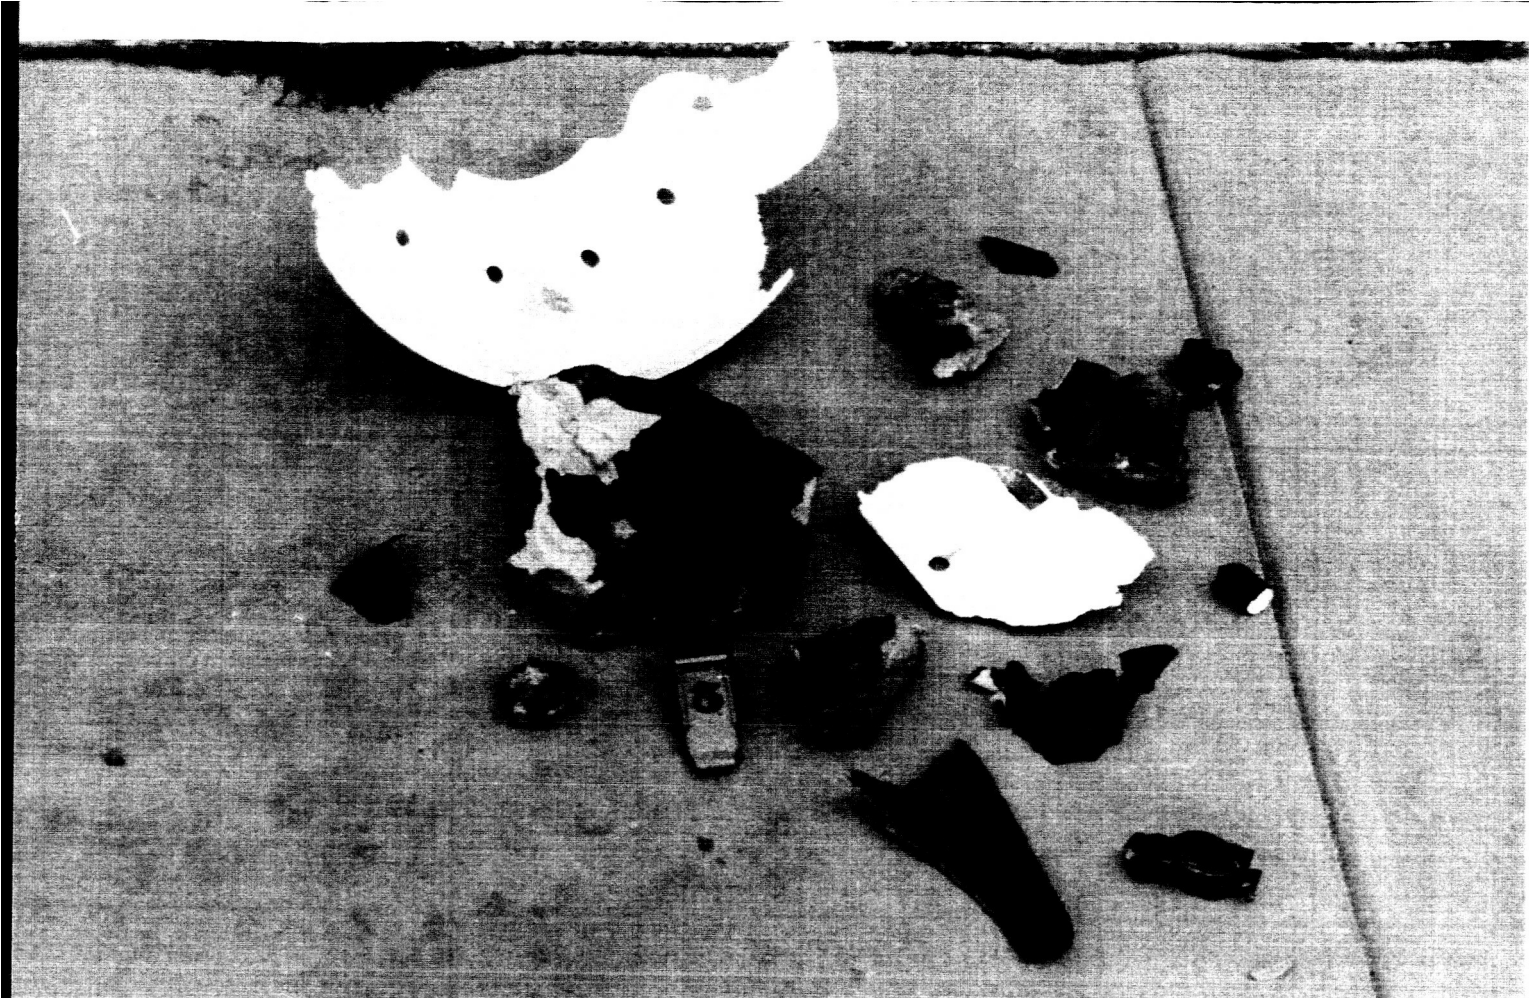
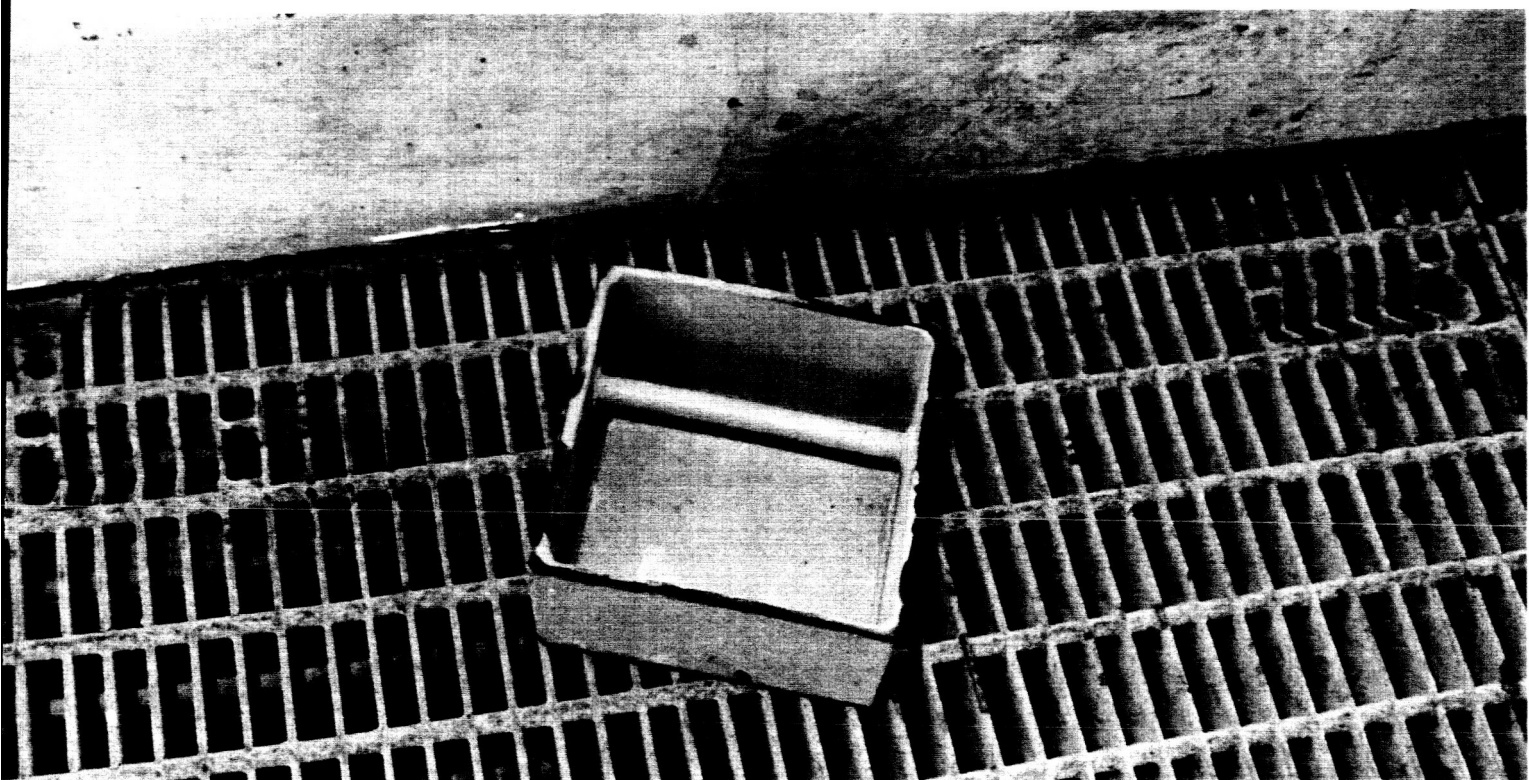
Typical post launch debris included facility covers and light fixtures, GH2 vent line insulation, miscellaneous brackets and fasteners, facility paint scale, SRB throat plug material, and one Orbiter Q-felt plug found near the ESP park site.

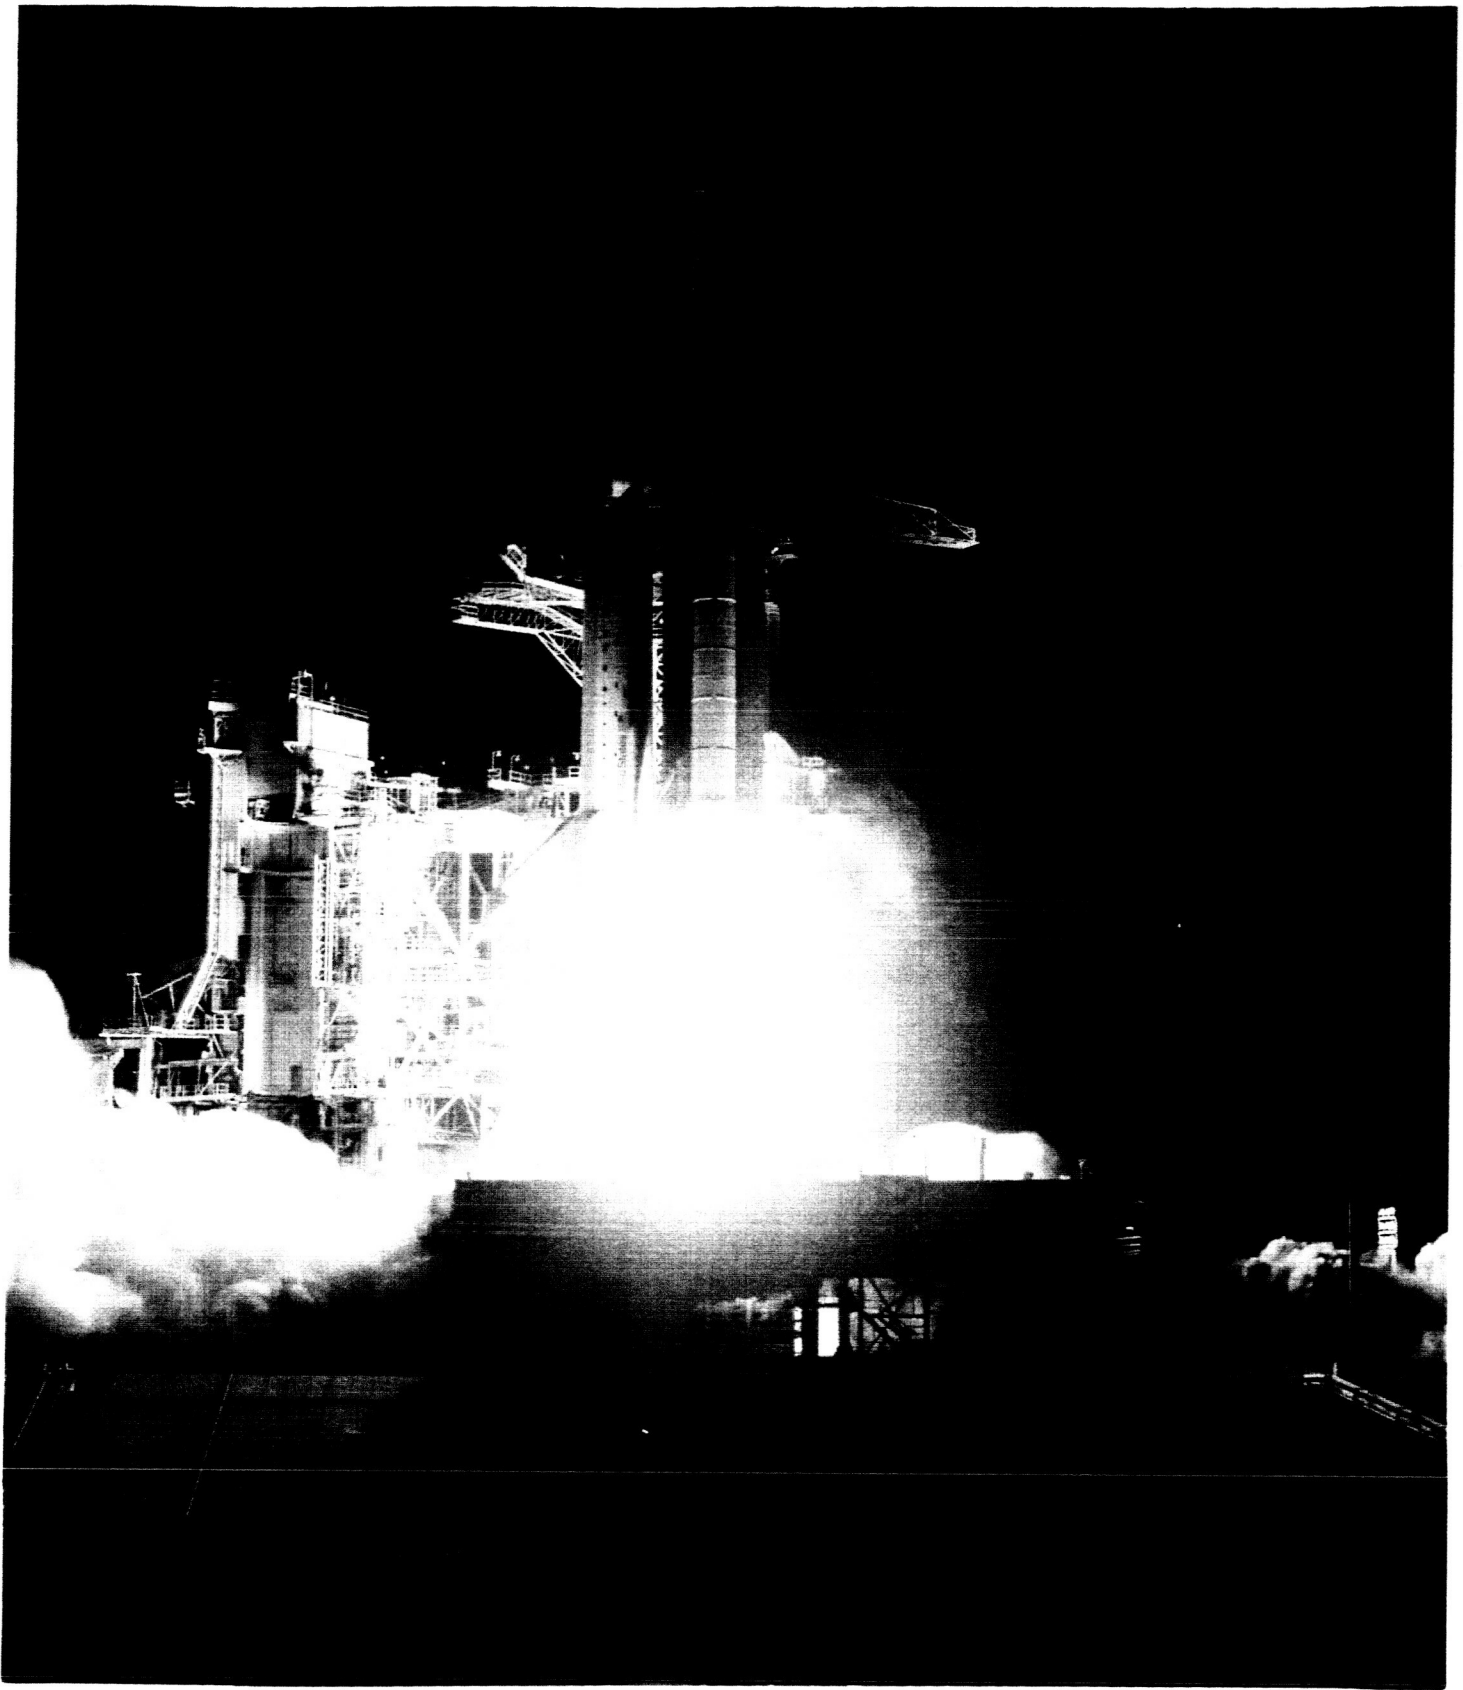
Numerous particles of SRB throat plug material were ejected out of the exhaust holes after T-0, an expected occurrence, but none trailed smoke like those observed during the STS-38 launch.

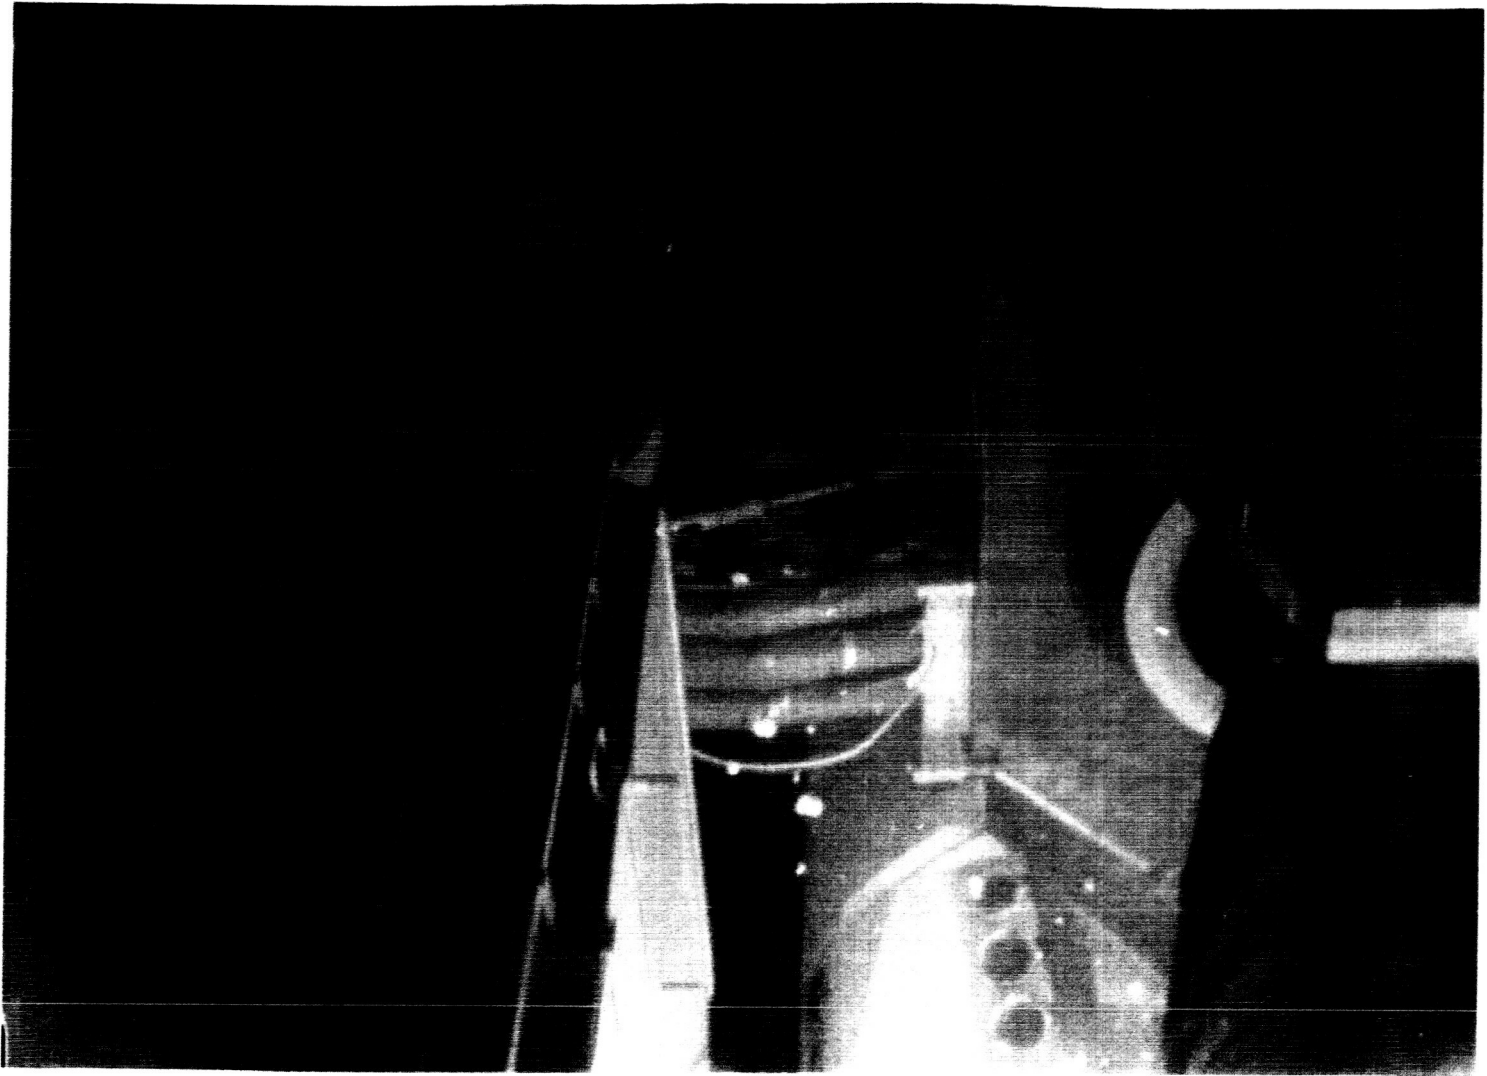
SSME ignition caused pieces of ice to shake loose from the L02 T-0 umbilical/TSM interface. None of the ice particles contacted the Orbiter. SSME ignition vibration/acoustics also caused pieces of tile surface coating material to shake loose from the upper surface of the elevons (arrows).

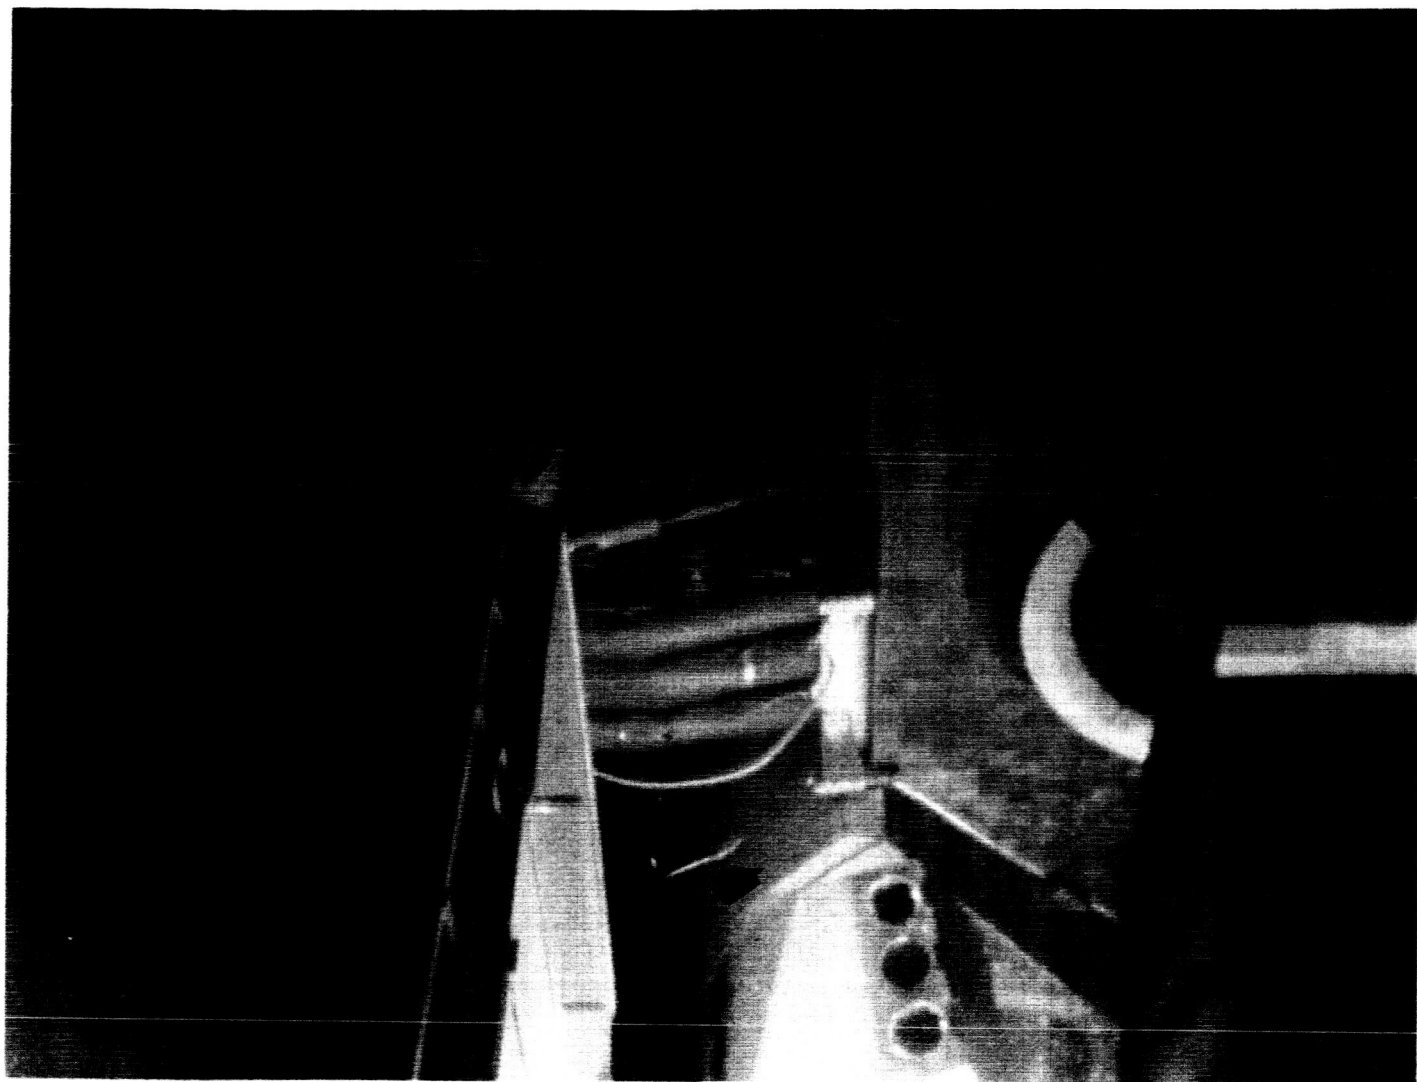
A debris object, most likely a tie-wrap, fell from the L02
TSM door just after the T-0 carrier plate began to retract

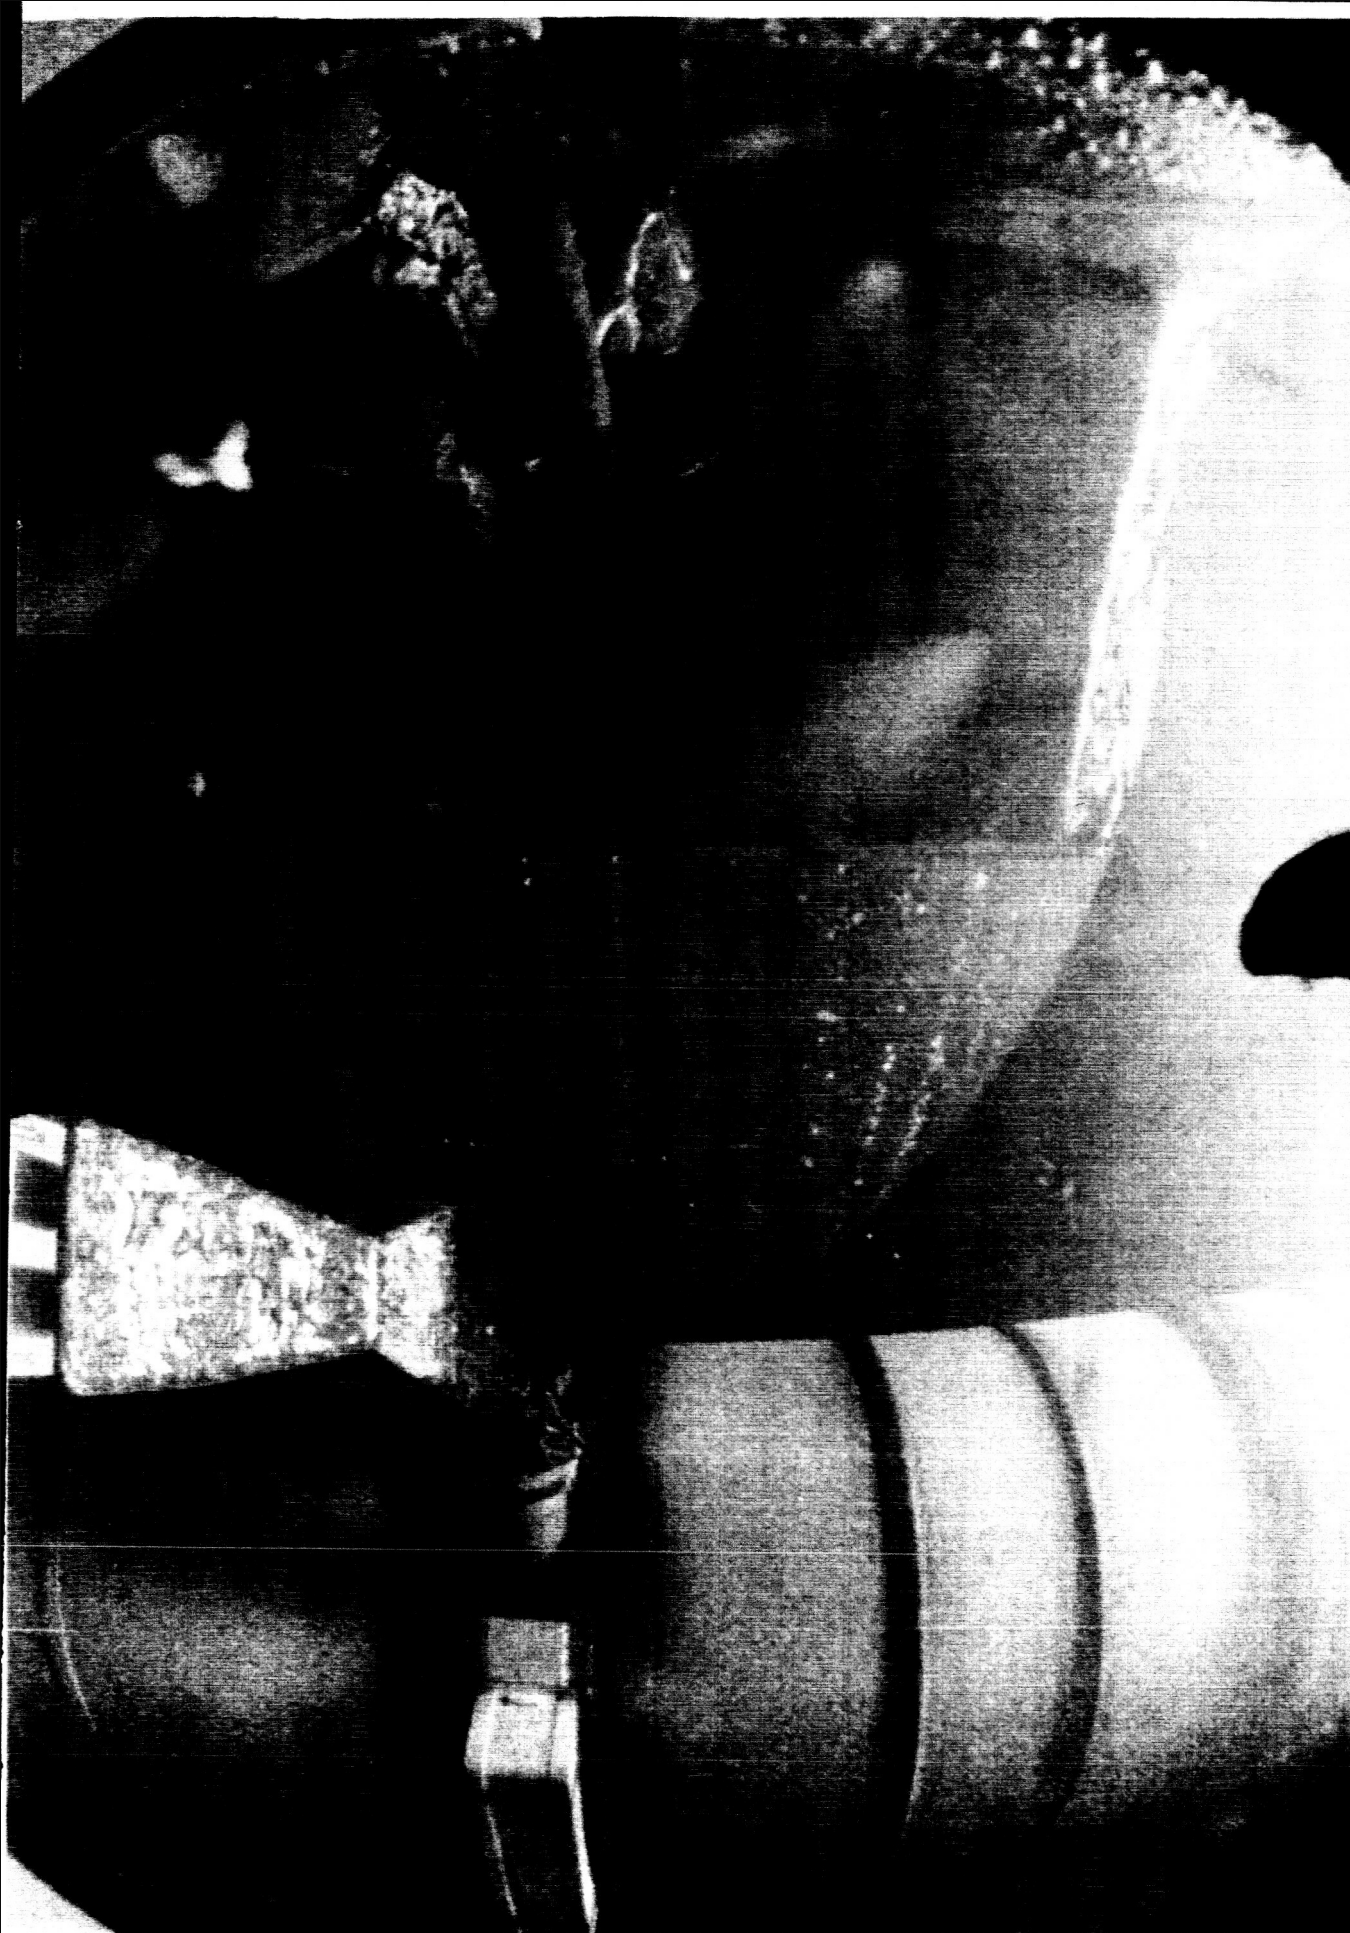
Orbiter LH2 umbilical camera recorded typical aerodynamic/thermal erosion of the TPS on the aft surfaces of the umbilical and cable trays. ET aft dome charring was caused by plume recirculation.

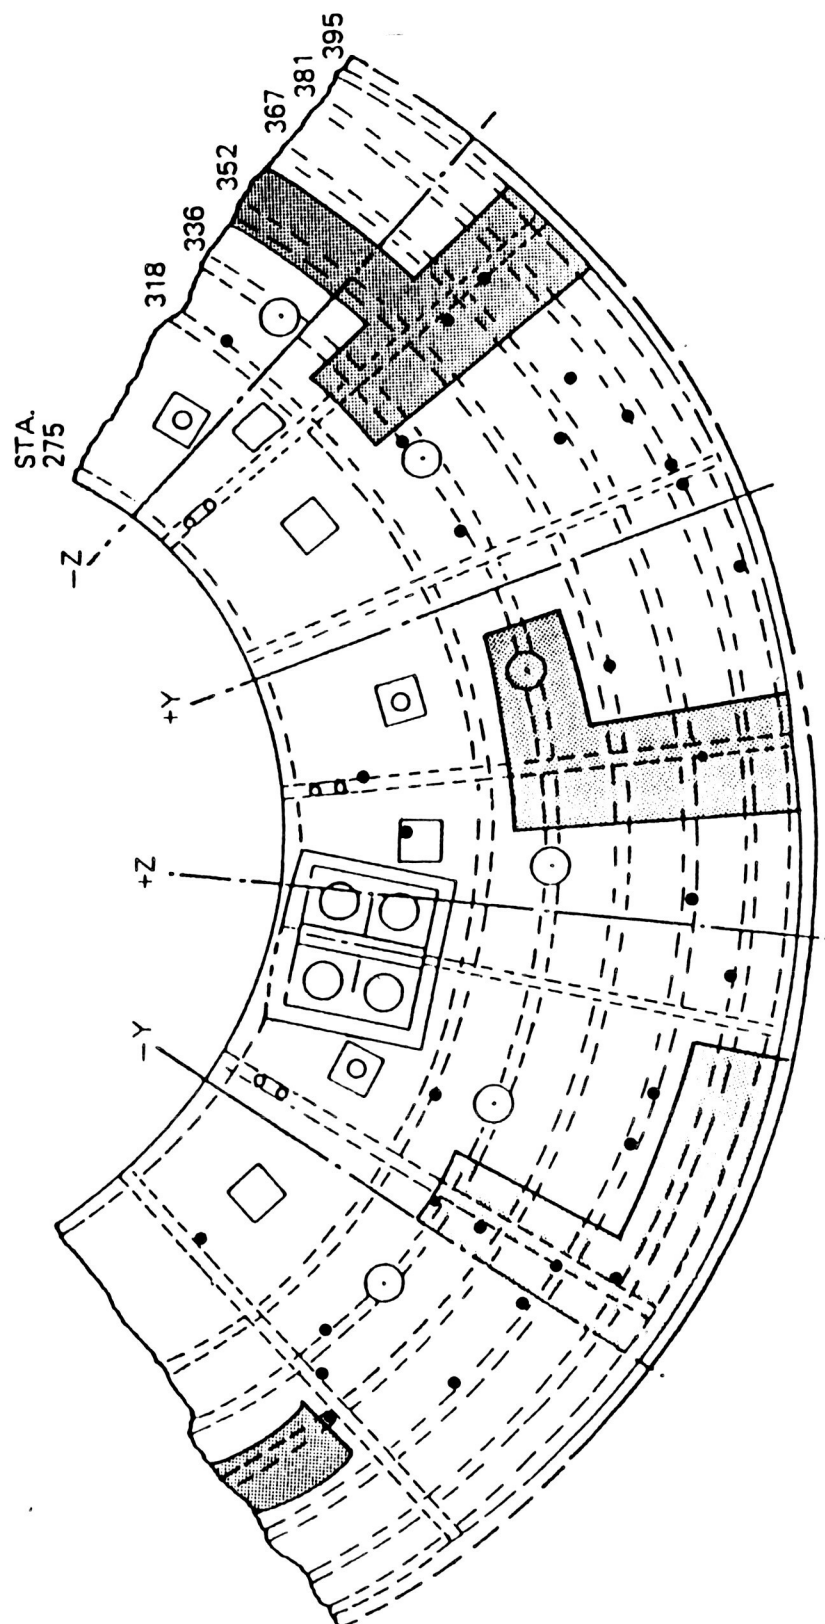
FIGURE 5. RIGHT SRB FRUSTUM

<u>MISSING TPS</u>	<u>DEBONDS</u>
NONE	30 DEBONDS OVER FASTENERS

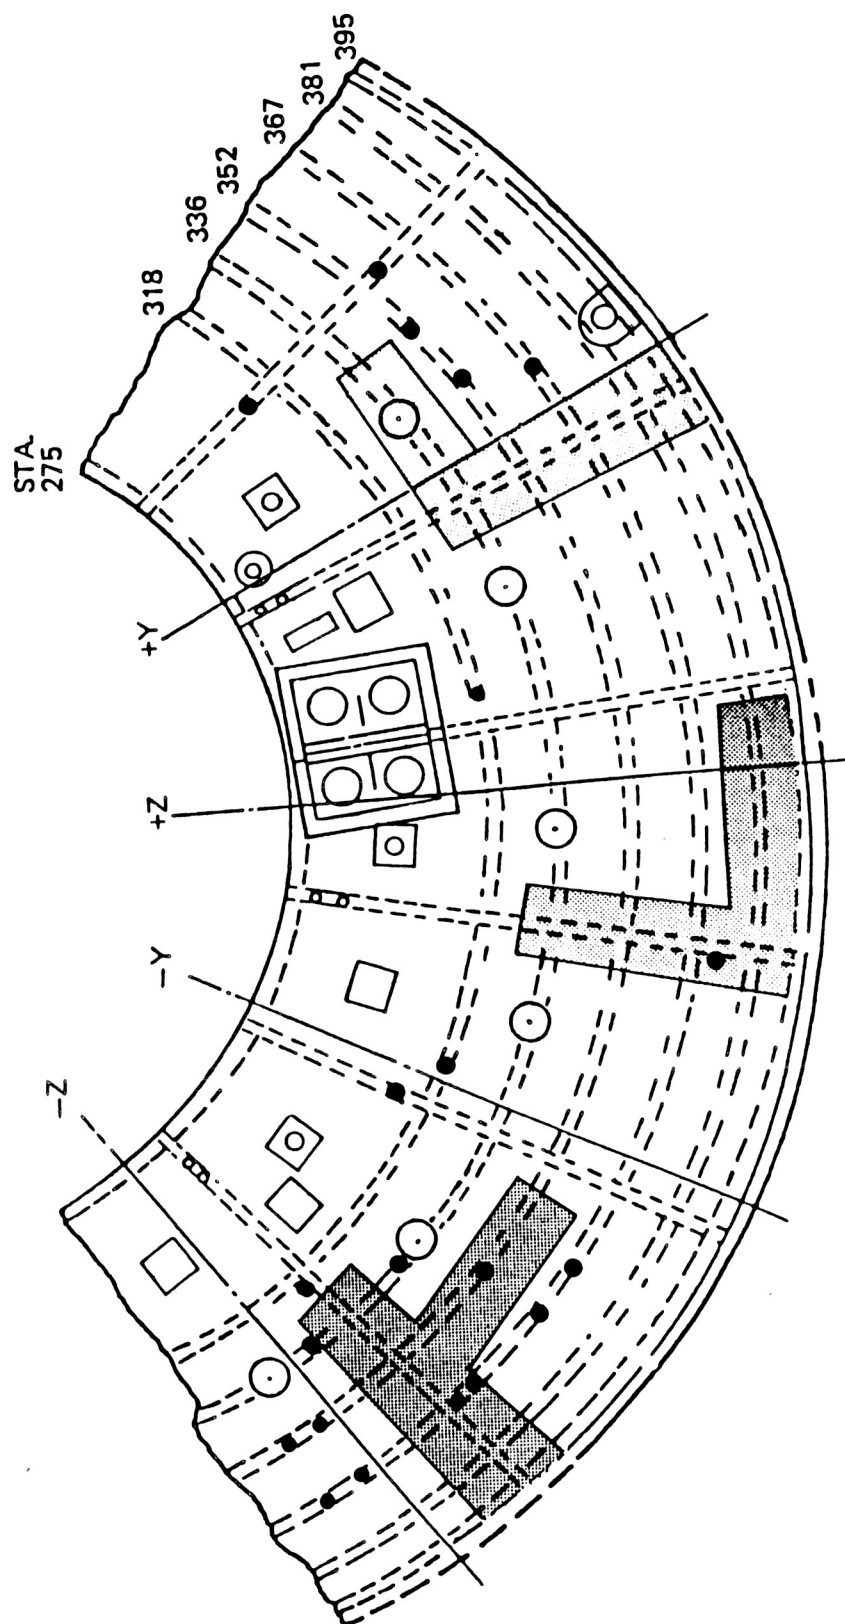
FIGURE 8. LEFT SRB FRUSTUM

The nose cap was not recovered. The LH frustum exhibited no missing TPS but had 21 MSA-2 debonds over fasteners (Figure 8). Two BSM covers were fully opened but the lower left and lower right covers had been bent by parachute riser entanglement after water impact. Hypalon paint had blistered along the 395 ring.

TPS MISSING	DEBONDS	NOTES
NONE	21 DEBONDS OVER FASTENERS	HYPALON PAINT BLISTERED ALONG 395 RING

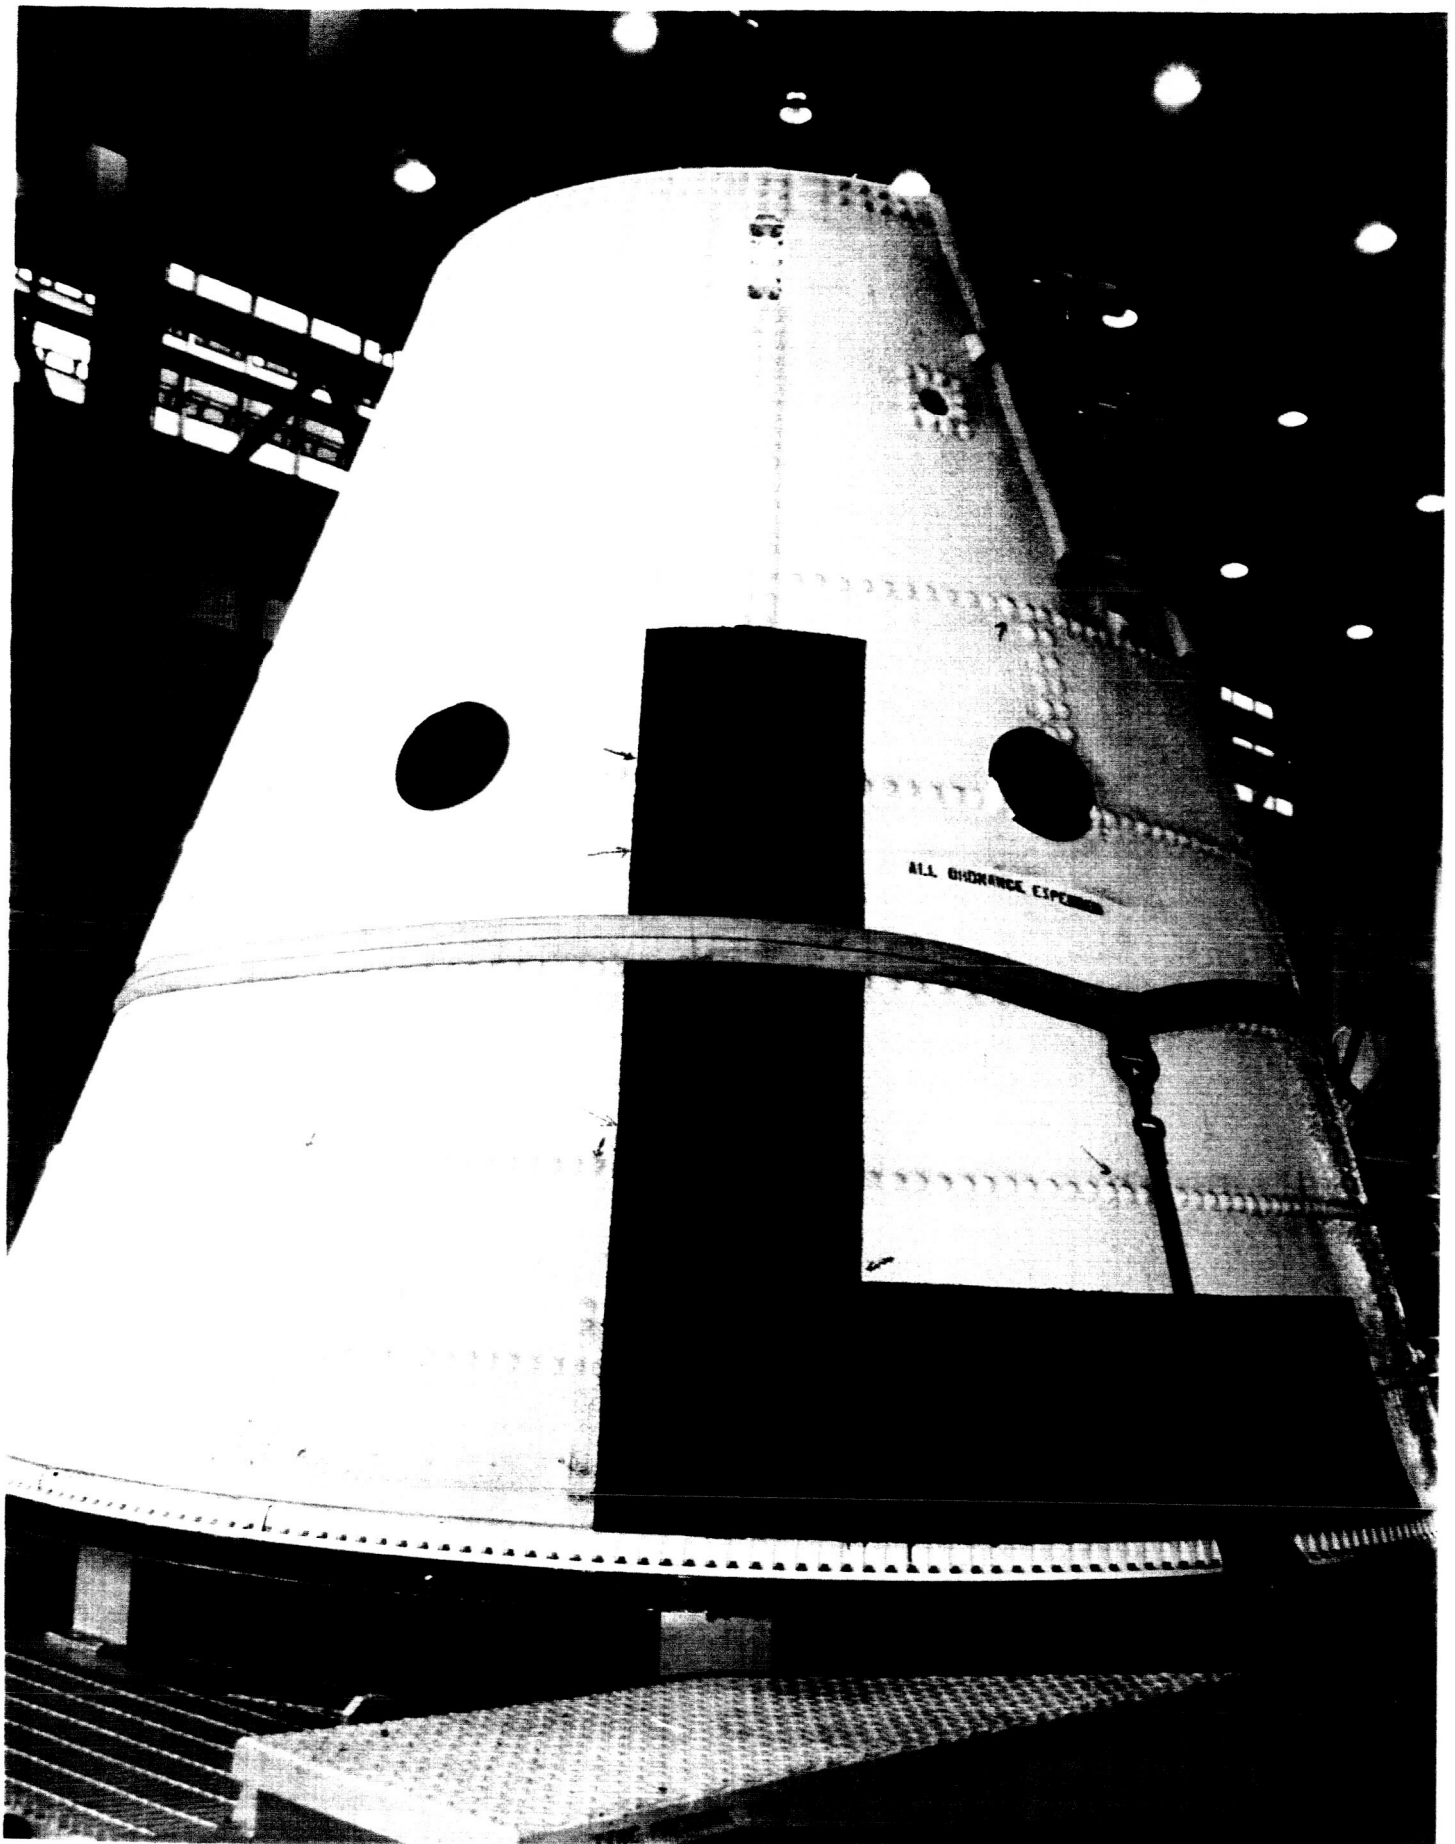
Post flight condition of the RH frustum. There were 30 MSA-2 debonds over fasteners, but no areas of missing TPS.
